# EXPLOSION ACCIDENT EVALUATION OF MV. GILI CAT II USING APOLLO ROOT CAUSE ANALYSIS METHODOLOGY

Ricard Diago Sambuaga  
NRP 4213 101 046

DEPARTMENT OF MARINE ENGINEERING  
Faculty of Marine Technology  
Institut Teknologi Sepuluh Nopember  
Surabaya  
2017

*The highest percentage of accident investigation (2007-March 2017) of National Transportation Safety Committee (NTSC) is caused by fire or explosion (38%). MV. Gili Cat II had been exploded September 15<sup>th</sup>, 2016 at Padangbai port, Bali. MV. Gili Cat II is a passenger ship that serves from Padangbai Port, Bali to Gili Ketapang, Lombok. There were 35 passengers on board when ship was exploded. From this accident, there were 2 passengers got fatalities. Related to the explosion of MV. Gili Cat II, Root Cause Analysis and giving recommendation is needed (especially for electrical system and fuel oil system). Apollo Root Cause Analysis that used in this thesis. This is recommended for event / incident-based items of complex and higher significance. Recommendation of this thesis is referring the NCVS (Non-Conventional Vessel Standard) Ch. V and NFPA refueling procedures. As the result of the analysis, the explosion is cau

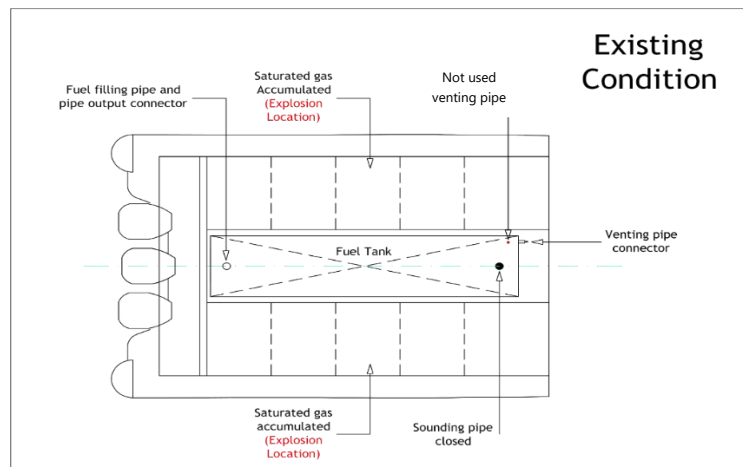
MV. Gili Cat II explosion location is in below of the deck. Location of the explosion is beside of the fuel tank. Explosion can happen caused by saturated gas are accumulated in that below deck. After saturated gas accumulated, then there is mixing between air (oxygen) and saturated gas (Fuel) and an Igniter. Because of these three elements so explosion can happen. Figure 4. 3 is described location of the explosion and the layout of the ship. The discussion of this case is described in Figure 4. 4.

Figure 4. 3 Detail Location of the Explosion<sup>5</sup>

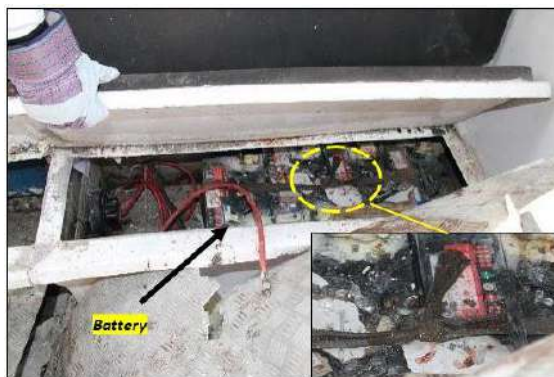
There are evidences for each cause. Those evidences for tightening battery using belt tied manually and wood boards and sponges used as a prop for battery are described in Figure 4. 7 and Figure 4. 8.

*Figure 4. 7 Evidence for Tightening Battery Manually<sup>9</sup>*

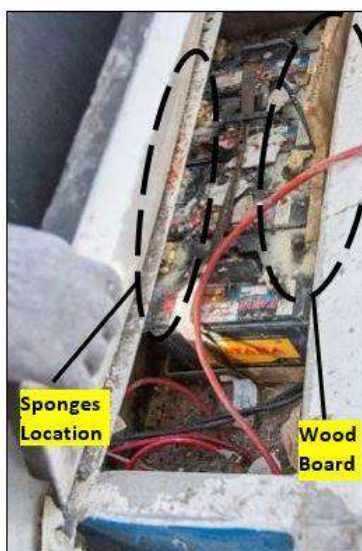
*Figure 4. 8 Evidence for Wood boards and sponges used as a prop for battery<sup>10</sup>*

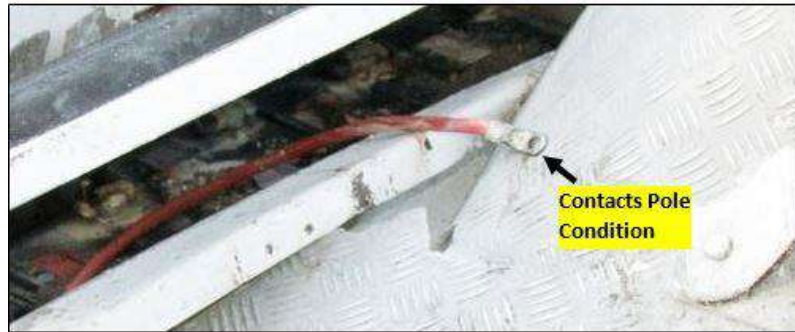
Figure 4. 9 Evidence for contacts pole condition (without isolator)<sup>11</sup>

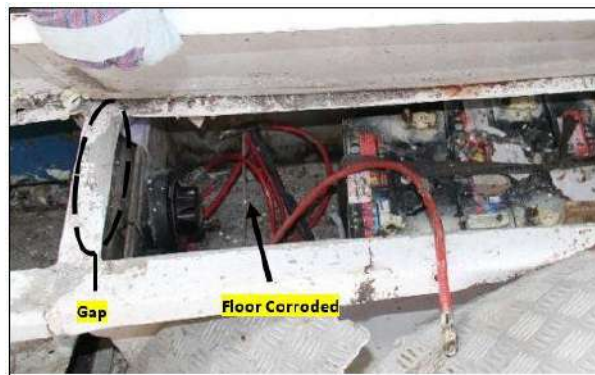
Figure 4. 10 Evidence for battery spaces is not in good condition<sup>12</sup>

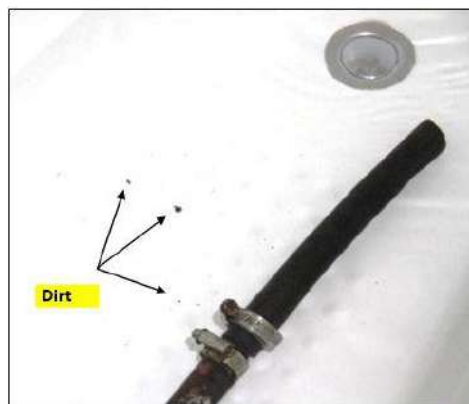
Figure 4. 16 Evidence for Air could not be circulated <sup>18</sup>

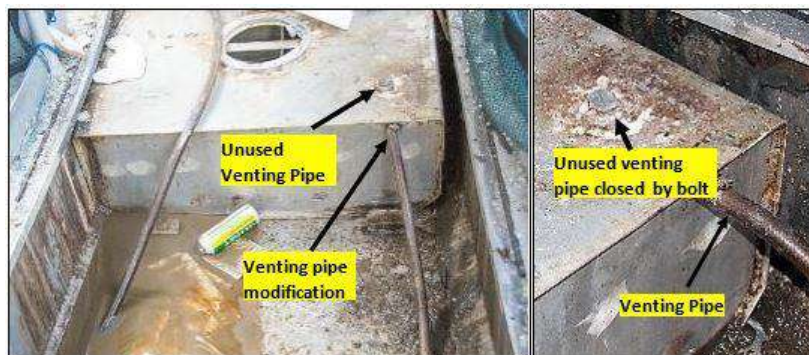
Evidence for venting pipe mounted moved position is described in Figure 4. 19. Figure 4. 19 describe that the previous venting pipe mounted was not used anymore and ship owner do the modification of venting pipe mounting. The modification made caused by MV. Gili Cat II operate always in trim by stern condition but a new modification venting pipe system is not work well, said NTSC Investigator. Present venting pipe design is not work well so saturated gas cannot release through the air. An unused venting pipe is closed by bolt.

Figure 4. 19 Evidence for venting pipe moved position<sup>21</sup>

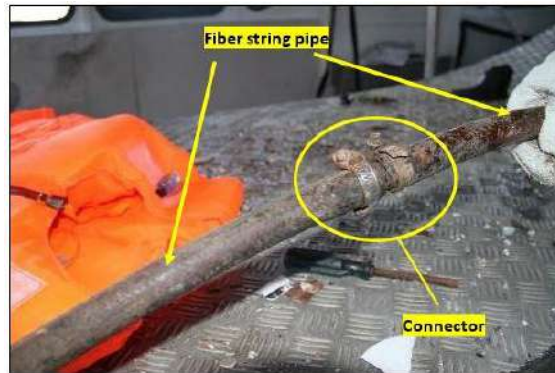
Figure 4. 21 Evidence for Venting pipe connector bad condition<sup>23</sup>

Bad condition of venting pipe connector cause saturated gas of fuel cannot release well. Corrosion of the connector made

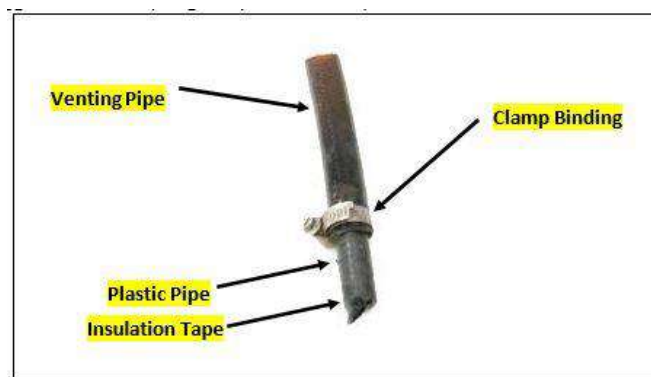
Figure 4. 22 Evidence for plastic pipe inserted between two pipes<sup>24</sup>

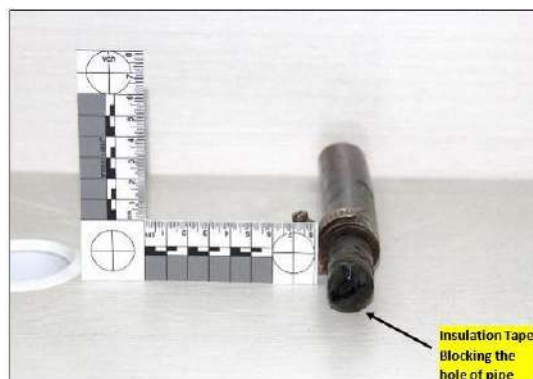
Figure 4.23 Evidence for insulation tape blocking venting pipe hole<sup>25</sup>

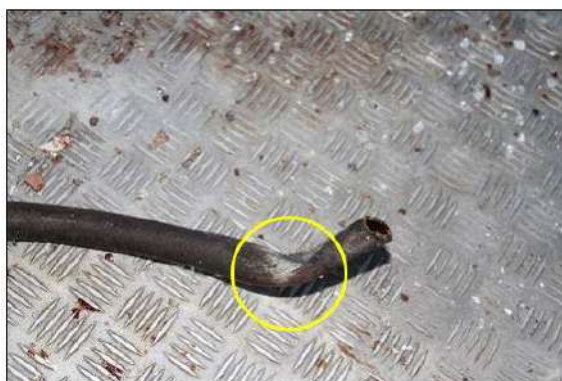
Evidence for venting pipe folded described in Figure 4. 25. Venting pipe folded are caused by design is not good. Bad design makes venting pipe folded forcibly so saturated gas cannot release. Venting pipe is using flexible hose. If the flexible hose is folded forcibly time by time the pipe condition is getting worse.

*Figure 4. 25 Evidence for venting pipe folded<sup>27</sup>*

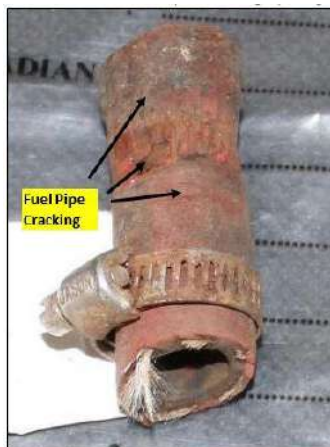
Figure 4. 27 Evidence for Material is not in good condition (Cracking) <sup>29</sup>

- 1.2.3.1 (A) Ship crews did not check well - STOP (Lack of Control)
- 1.2.3.2 (A) Ship crews did not check regularly - STOP (Lack of Control)
- 1.2.3.3 (C) Not using material standards - STOP (Desired Condition)

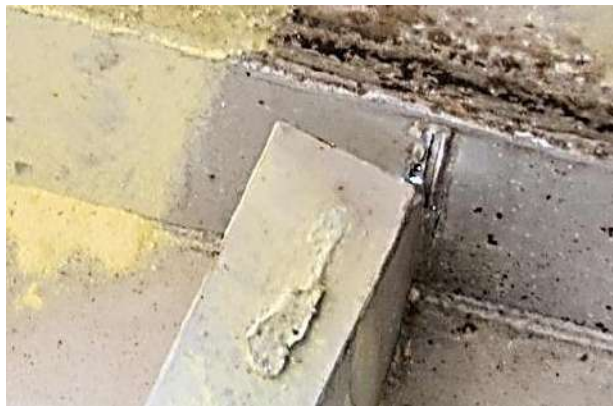
There is an evidence for each cause. Evidence for air come into compartement under deck, connection between hull wrang is not exhausted, and welding no the deck only using spot welding are described in Figure 4. 31.

*Figure 4. 31 Evidence for welding only using spot welding<sup>33</sup>*
